**TECHNICAL BACKGROUND REPORT to the  
SAFETY ELEMENT of the GENERAL PLAN  
for the CITY of HESPERIA,  
SAN BERNARDINO COUNTY, CALIFORNIA**

**SEISMIC HAZARDS  
GEOLOGIC HAZARDS  
FLOODING HAZARDS  
FIRE HAZARDS  
HAZARDOUS MATERIALS MANAGEMENT**

**EARTH CONSULTANTS INTERNATIONAL, INC.**

**February 2010**

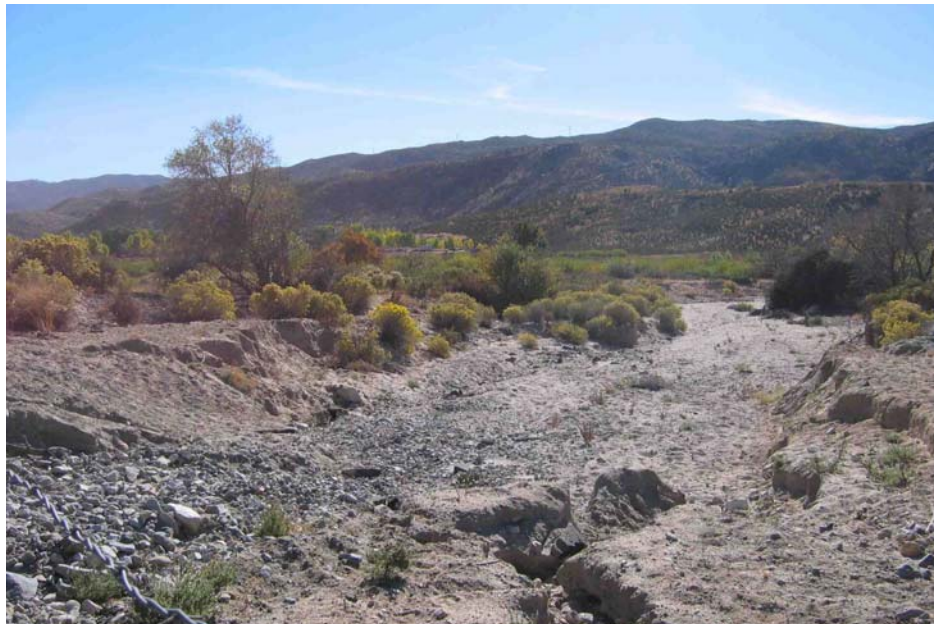
#### Figure 2-1: Very Young Wash Deposits in Horsethief Creek.

These sediments consist primarily of unconsolidated sand, gravel, and small boulders.

Very young wash deposits (Qw) consist of unconsolidated sand and gravel lining active drainage courses, including Oro Grande Wash, Horsethief Creek, West Fork of the Mojave River, and the Mojave River floodplain (Figure 2-1). Although too small to show on Plate 2-2, nearly all of the drainages west of the Mojave River have narrow, active channels that are filled with young, recently deposited sediments. North of the foothills, these sediments consist primarily of fine- to very coarse-grained sand with a lesser amount of gravel and pebbles. These deposits have no soil development on the surface, and may be reworked or buried by new sediment during winter storms. The upper reaches of the drainages, especially near the mountains may contain large boulders deposited during flash floods.

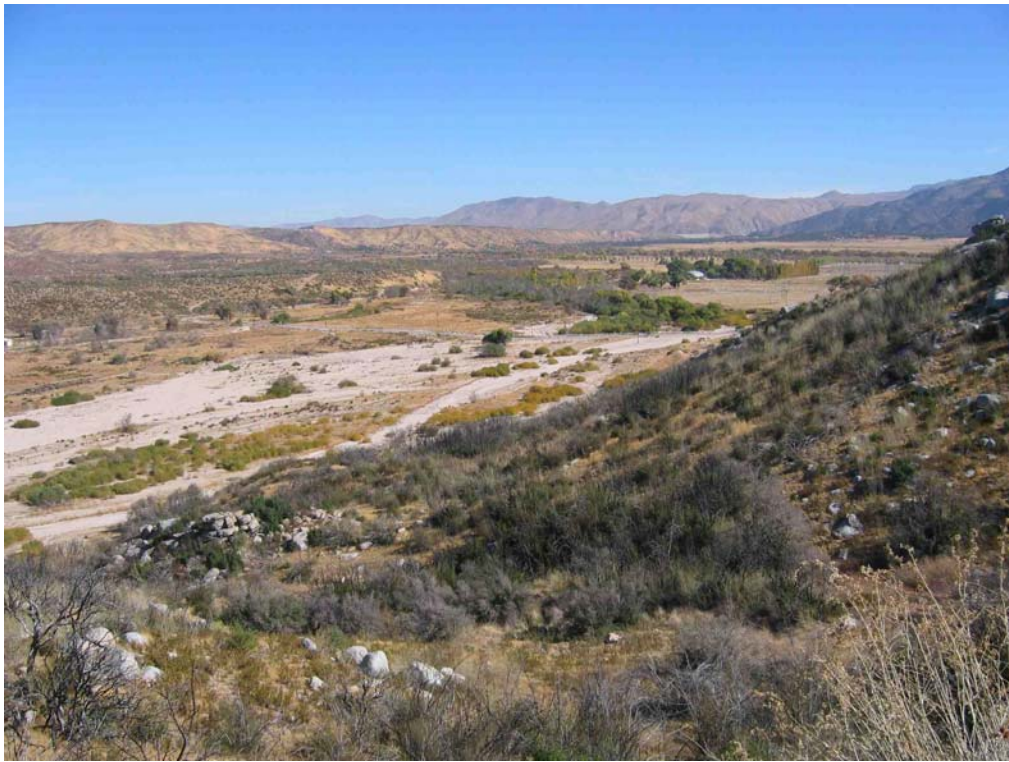
The elevated plateau on the top-left side of the photo is underlain by very old alluvial fan sediments. Most of the valley floor is covered with young alluvial fan sediments, with very young wash deposits of Horsethief Creek in the foreground. The mountains on the right side of the photo are comprised of ancient granitic rocks.

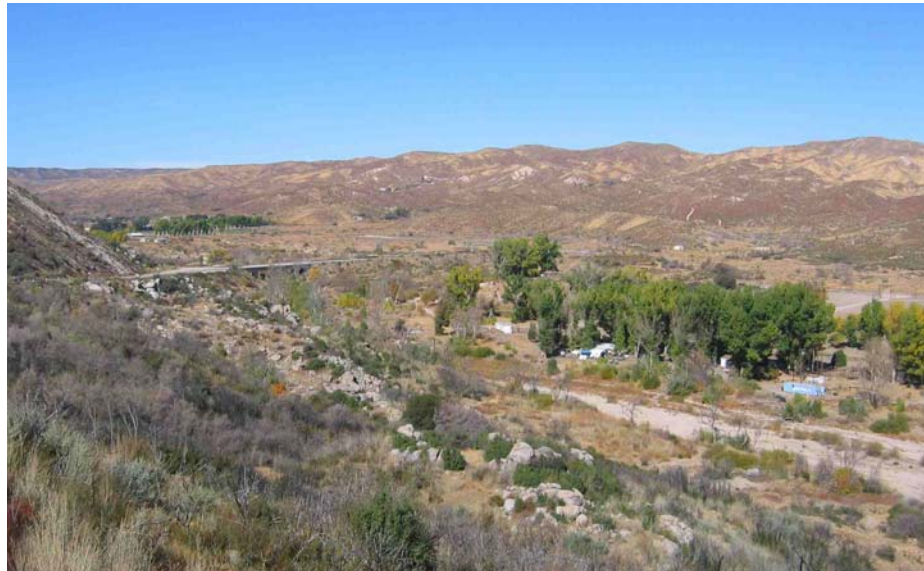
Pinkish-colored foothills are underlain by sandstone, pebbly sandstone, and conglomerate of the Crowder Formation. Highway 138 bridge across Horsethief Creek is on the left.
