Preliminary Geotechnical and Infiltration Feasibility Investigation  
Proposed Tamarisk Apartments, Phase 2 APN 3057-121-08

**PRELIMINARY GEOTECHNICAL AND  
INFILTRATION FEASIBILITY INVESTIGATION  
PROPOSED TAMARISK APARTMENTS, PHASE 2  
APN 3057-121-08  
HESPERIA, CALIFORNIA**

**PROJECT NO. 34002.1  
JUNE 5, 2024**

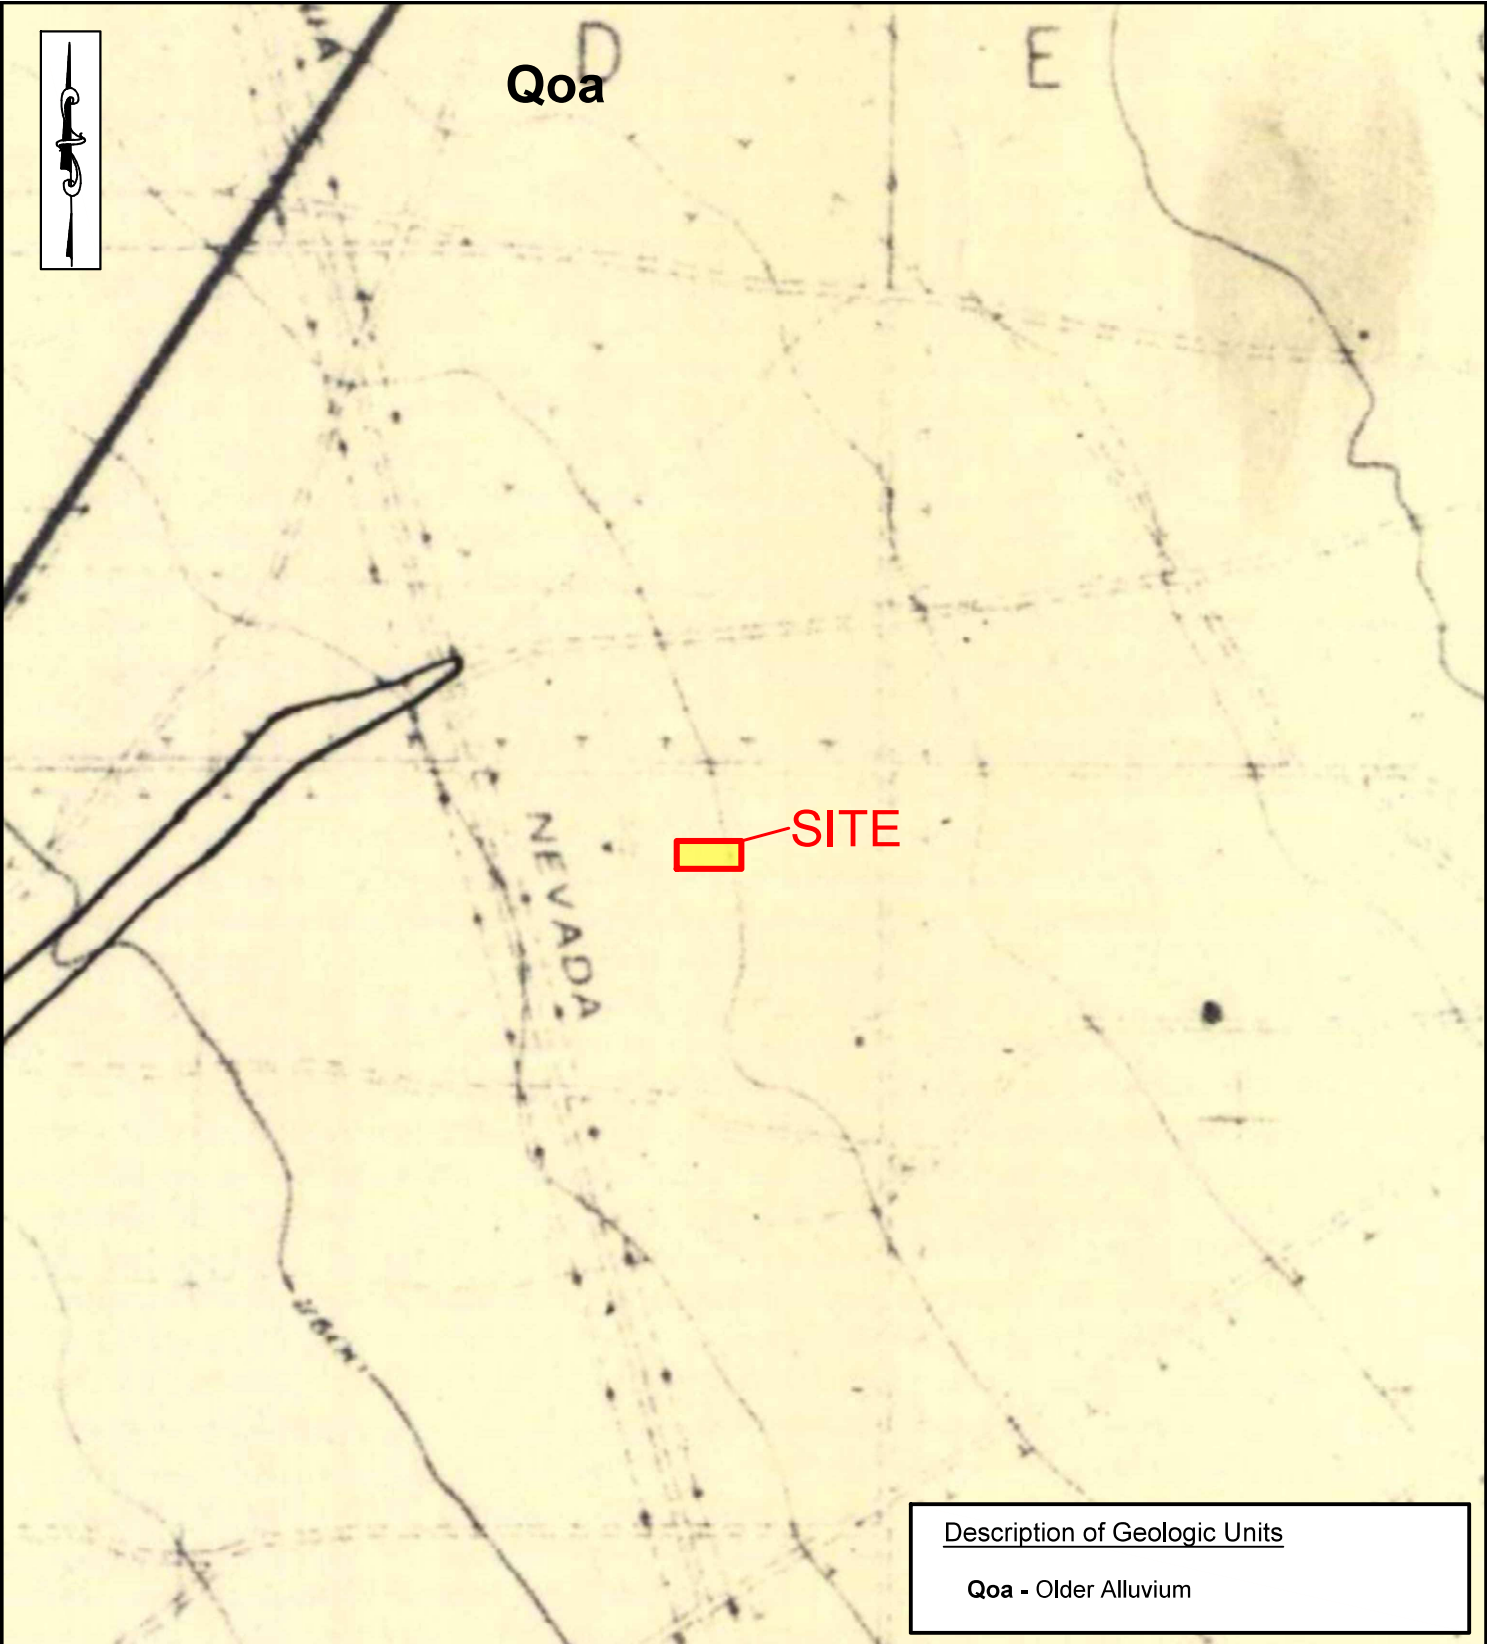
Description of Geologic Units

Qoa - Older Alluvium

A geological map of the site is presented as Enclosure A-4, within Appendix A. A detailed description of the subsurface soil conditions as encountered within our exploratory borings is presented on the Boring Logs within Appendix B.

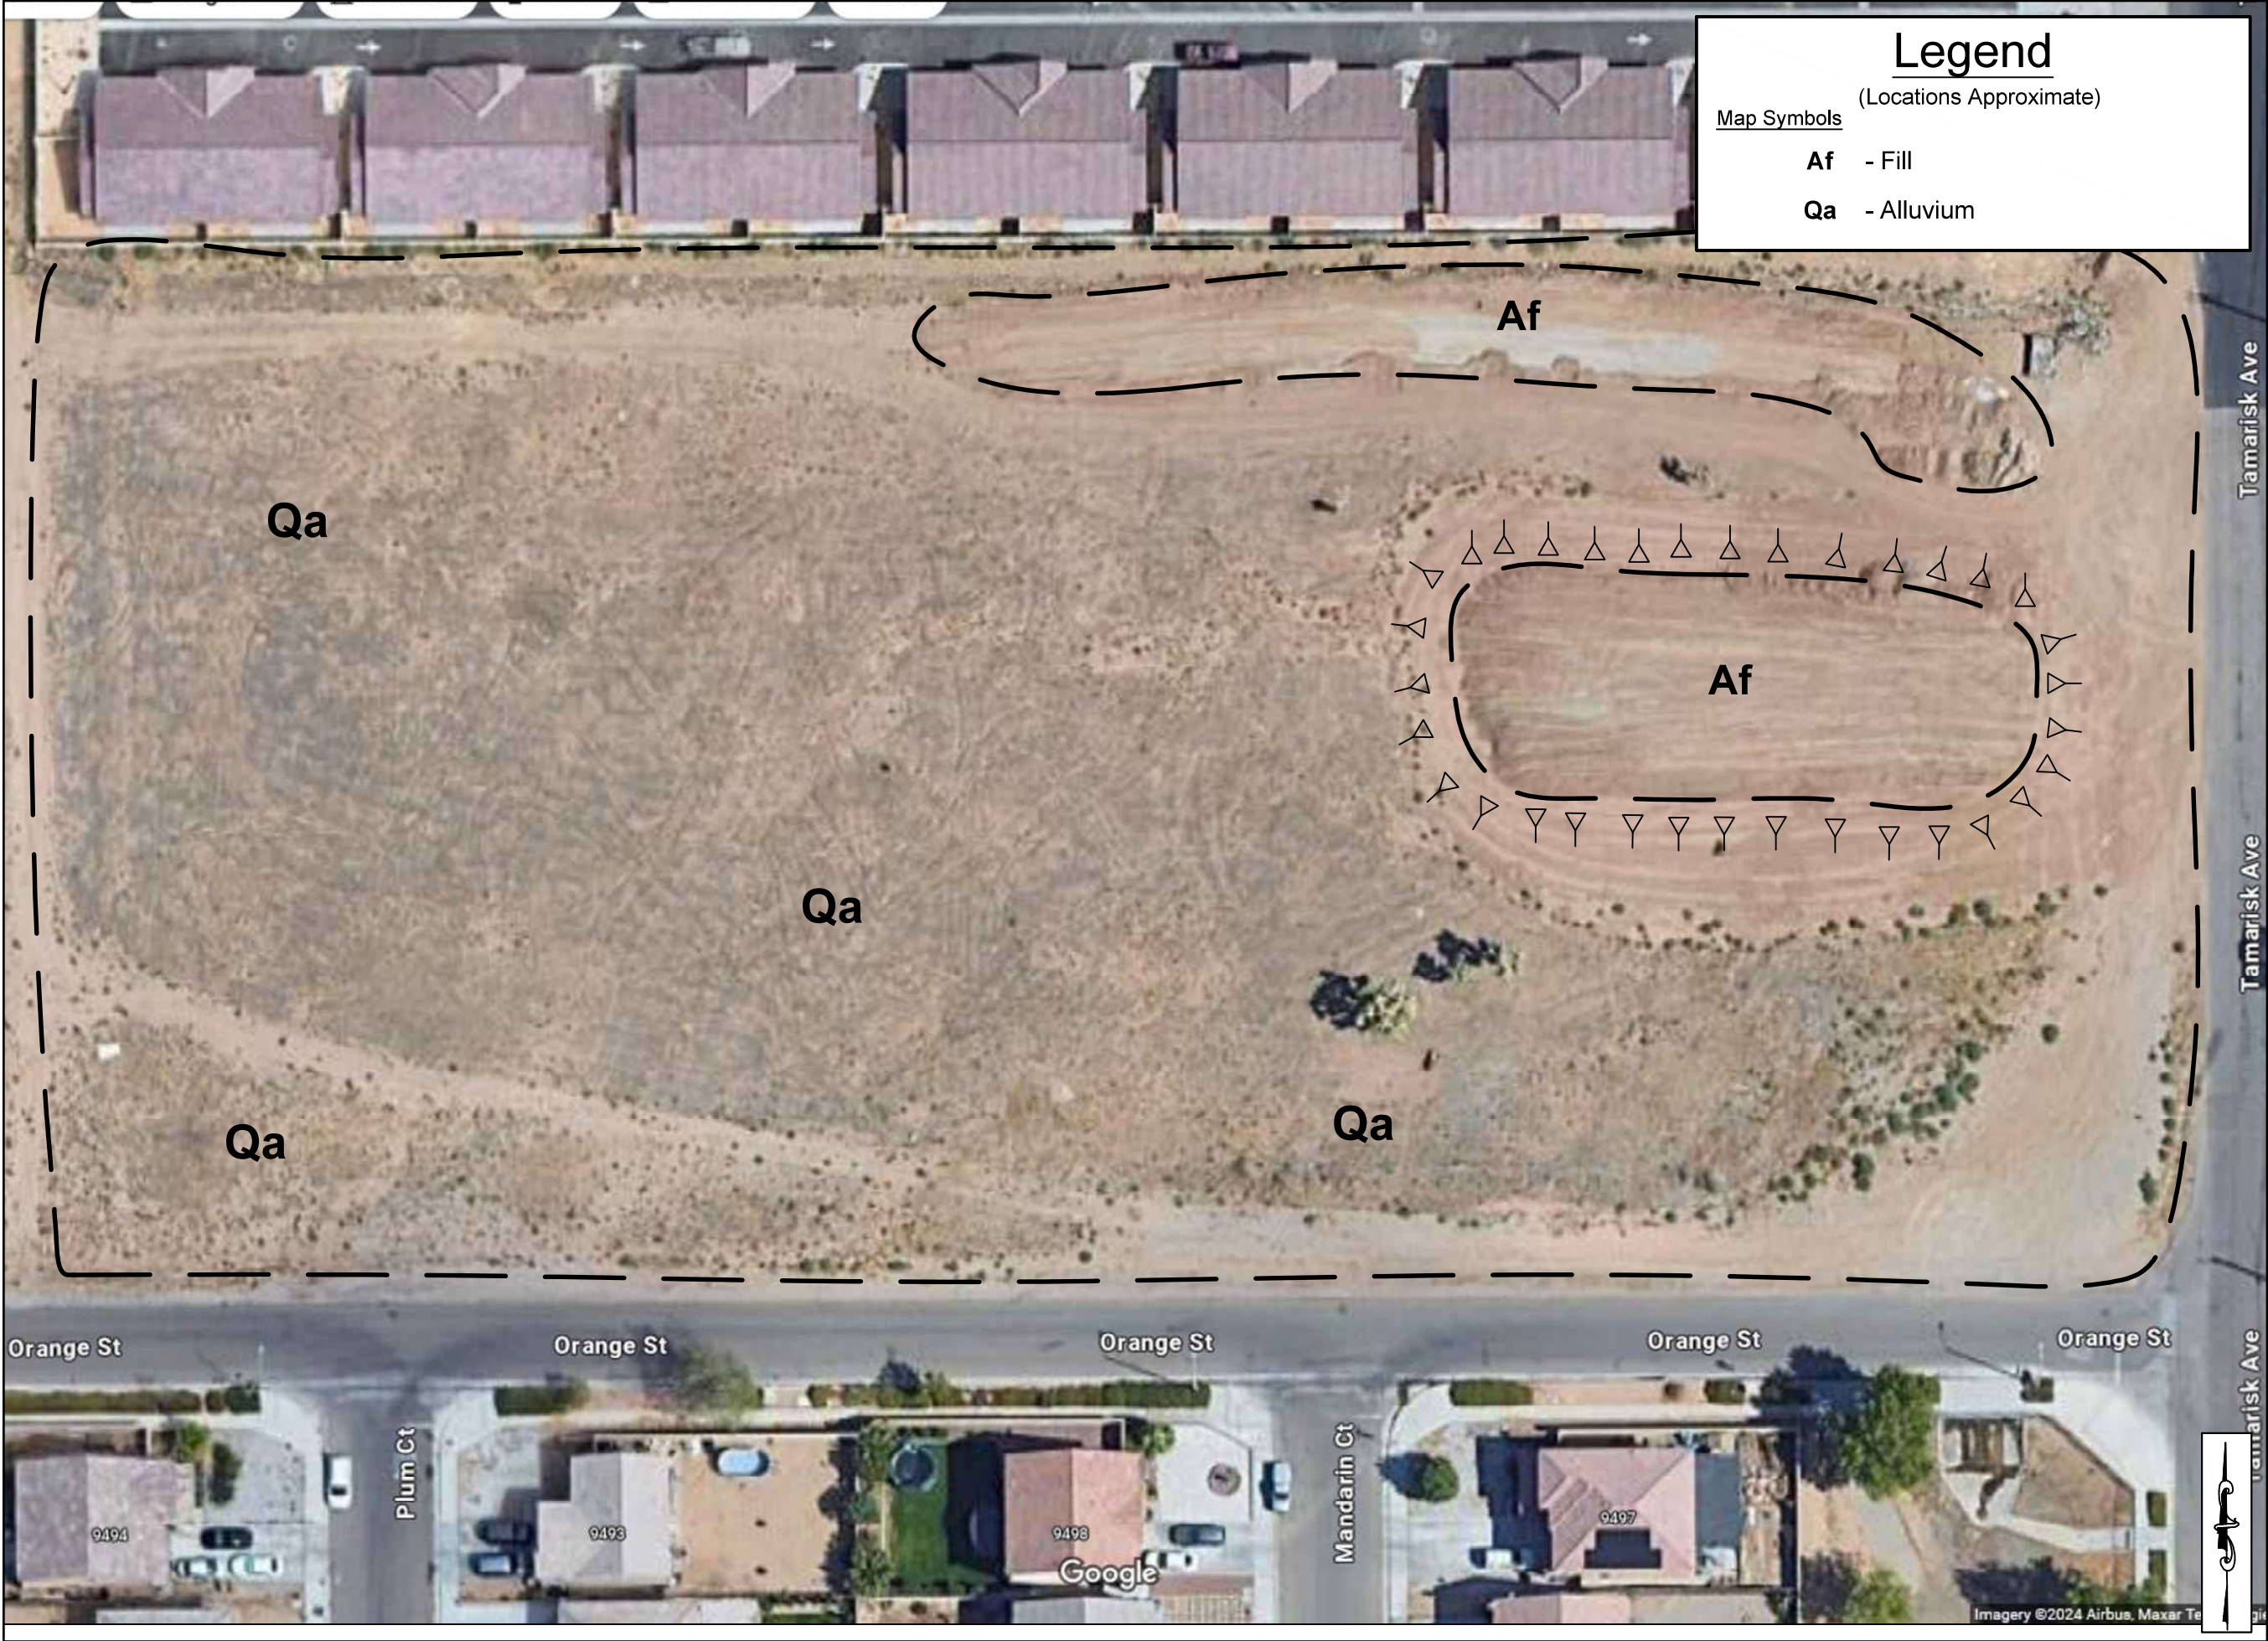
U.S. Geologic Survey (2024) real-time earthquake epicenter map. Plotted are 86 epicenters of instrument-recorded events from 01/01/78 to present (05/28/24) of local magnitude 1+ within a radius of ~9.2 miles (15 kilometers) of the site. Location accuracy varies. The site is indicated by the green square (■). The selected magnitude corresponds to a threshold intensity value where very light damage potential begins. These events are also generally widely felt by persons. Red lines mark the surface traces of known Quaternary-age faults.

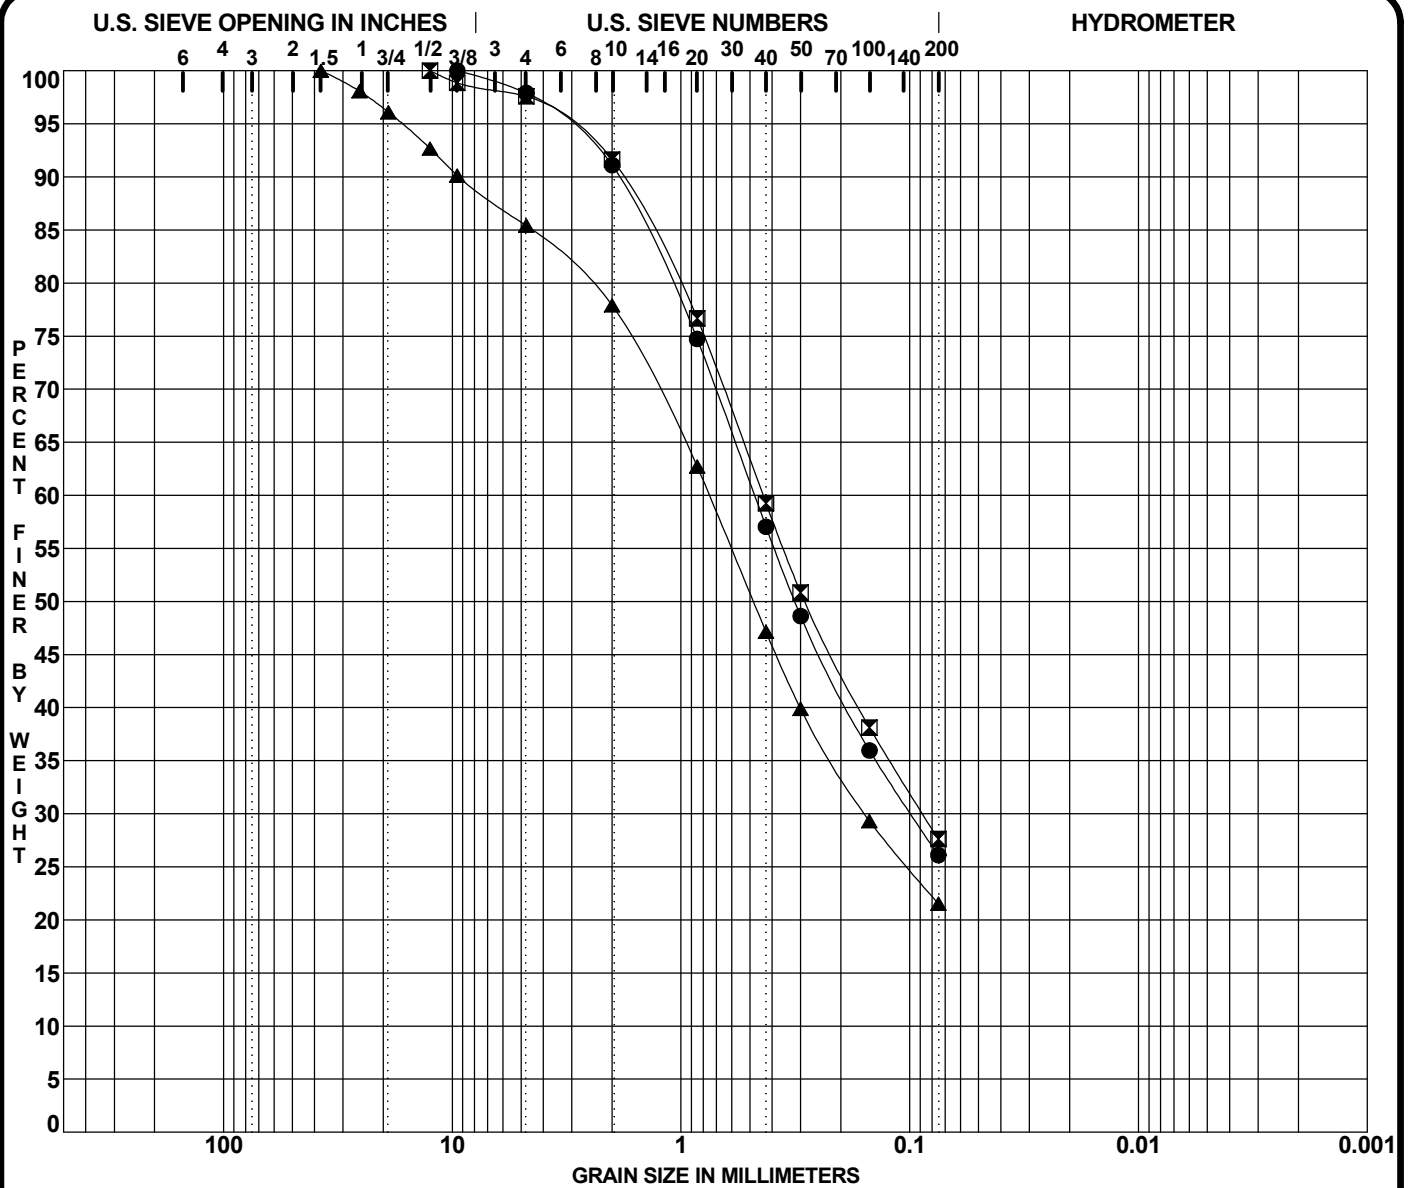
| COBBLES | GRAVEL | | SAND | | | SILT OR CLAY |
| | coarse | fine | coarse | medium | fine | |
